DEMONSTRATING WATER SAVINGS THROUGH SUBSURFACE TURF IRRIGATION

HENDERSON, NEVADA

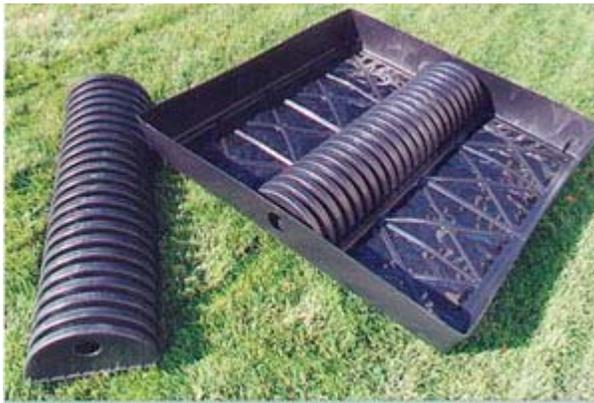
drains is funneled to this storage reservoir. The picture at left is the EPIC chamber shown with its accompanying pan.

The EPIC system consists of three distinct elements that are combined to work together, namely the liner pan, the EPIC chamber, and the sand fill that covers and surrounds the first two components. The only moving part in the system is water that is controlled by gravity and capillary physics to travel throughout the system in a predetermined order.

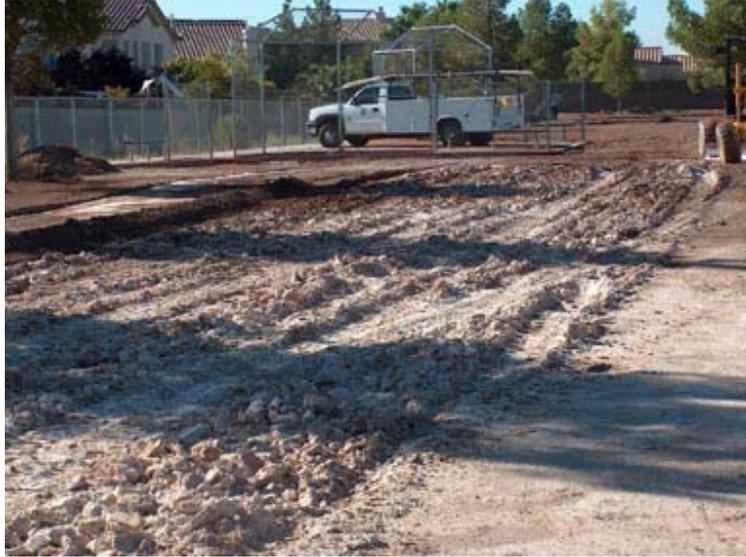
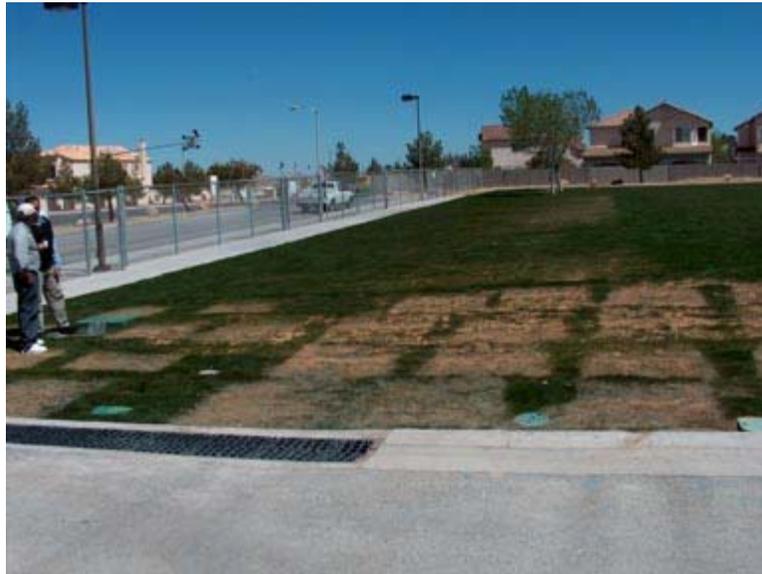
The more serious problem that created the largest water waste was undetected leaks in the liner. The liner itself is constructed of highly durable polyethylene and should be able to withstand normal wear and tear nicely. Unfortunately, a fall carnival was held at the elementary school and, unbeknownst to maintenance staff, trucks were driven on the field and tent spikes were hammered into the ground. It is believed that this trauma perforated the liners and lead to leakage. Even with such small leaks, a stable soil base would have been able to absorb the water. The site has a base of gypsum soil, which unbeknownst to the school district or product manufacturer, presented new problems to the system. As water leaked from the liner, water pooled underneath one of the water pans and melted away the gypsum soil forming a cavern. With the soil washed away, the water pan sunk lower. Because the system operates similar to the floating mechanism on a toilet bulb,

sensors read this lower seating as a decrease in water and continued to pump water into the pan resulting in a constant bathtub of water underneath the system. Because landscape maintenance staff is on site only one day per week, the problem went unnoticed for a longer than normal period of time and the leaks were not identified until the turf began to suffer. The pictures below show the heavily gypsum soils and turf damage because of the leaks.

Gypsum soil base.	The gypsum problem was one never before encountered with the EPIC system. Upon learning of the problem Jonas suggested that it could be avoided by depositing a clay base beneath the liner, which would absorb any water leaks before they reached the gypsum soil.

In retrospect, small tears in the liner were attributed to two causes. Alan believes that a number of tears resulted from improper activities conducted on the field during a school festival, namely driving on the field and hammering tent stakes into the field. The stakes likely passed through the sand and punctured the liner. Jonas also attributed some of the leakage due to placement of the liner over a mainline that ran through the field.

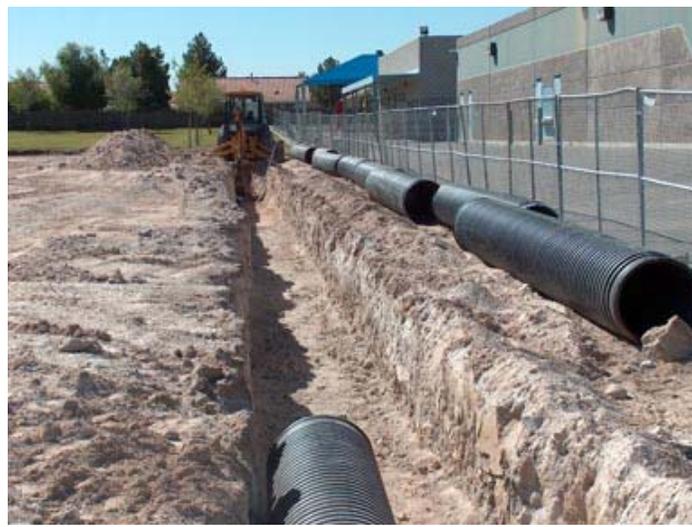
The field prior to installation
